REPORT ABOUT FINDINGS - LOOSE BRACKETS

FOR TAIL WING IN JORA UA2 1995 – BUILD no. 008

Author: Harald Sakshaug, Nedre Sørliveg 1, 7712 Steinkjer, Norway

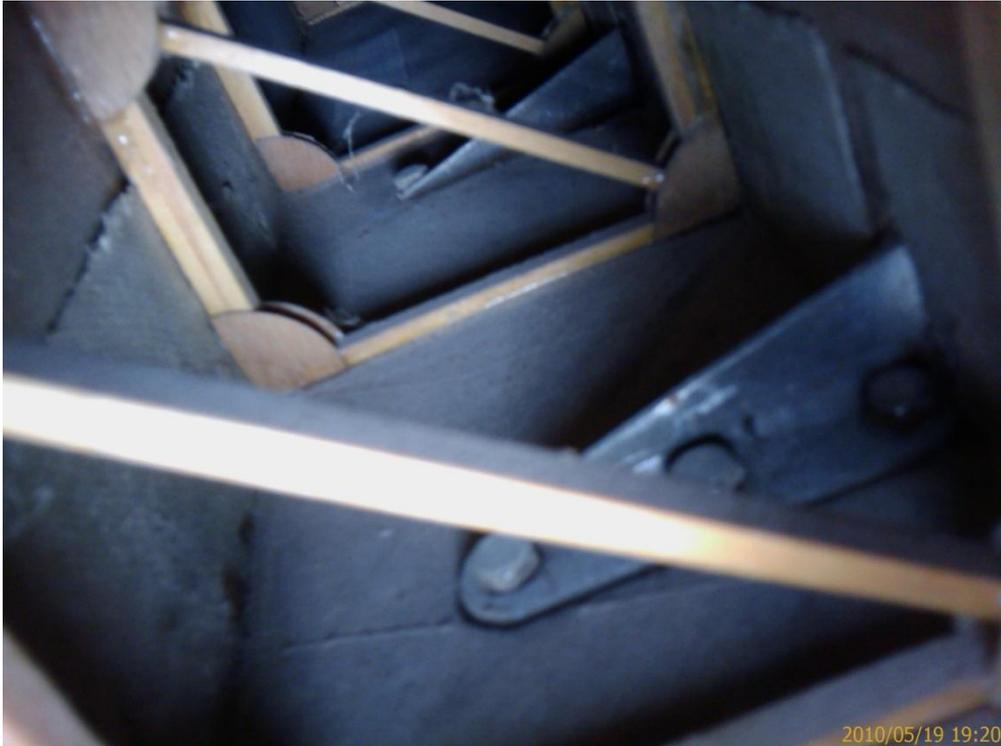
View of the inside fastening of the brackets before disassembly. There is no trace of glue, and the bolts are rather loose due to the plywood beam have expanded with temp. and seasonal changes.

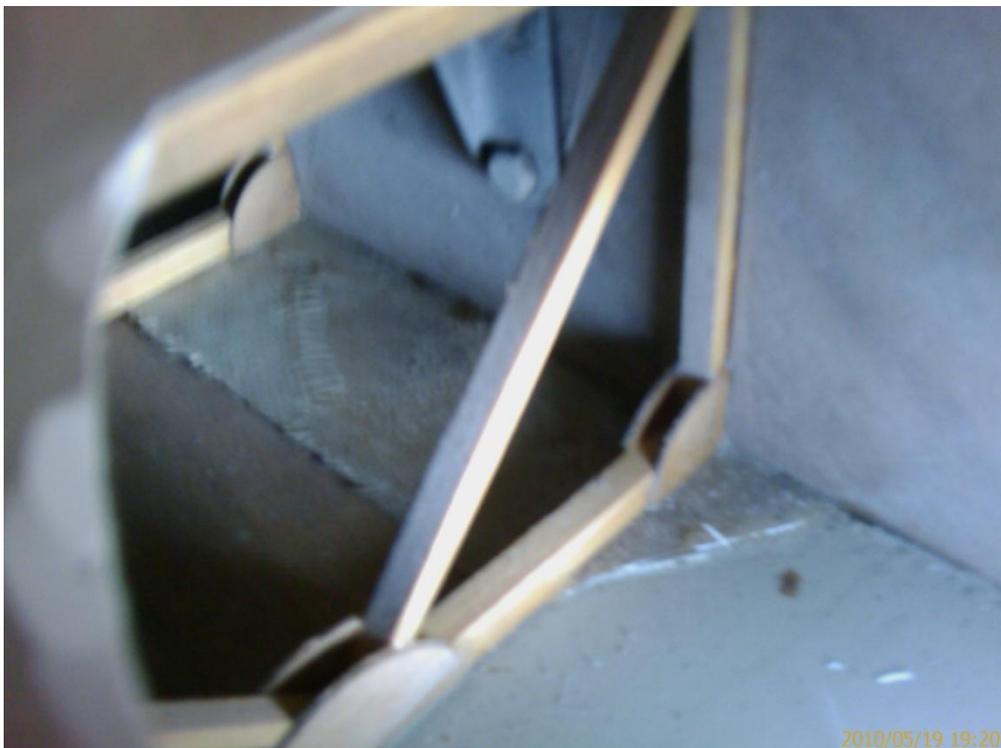
Apart from the fact that the brackets are loose, everything else looks good. Wood and glue have a good quality and there are no traces of damages. It appears with certainty that the bolts have worked loose due to vibration and seasonal changes, and not from a structural damage or overload.
