REPORT ABOUT FINDINGS - LOOSE BRACKETS

FOR TAIL WING IN JORA UA2 1995 – BUILD no. 008

Author: Harald Sakshaug, Nedre Sørliveg 1, 7712 Steinkjer, Norway

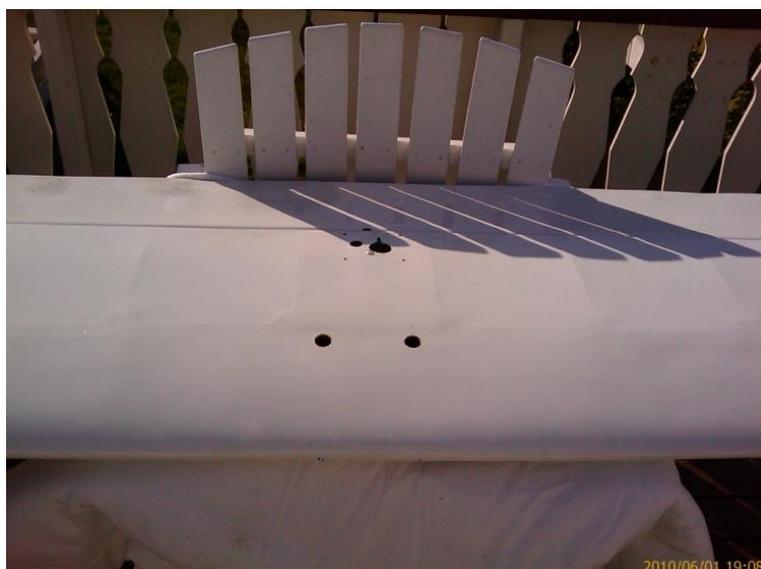
The above picture was agreed with the factory to be a good way to get inside for repair. The holes were first drilled 22 millimeters, but increased to 42 for access with tools.

The repair is easier to get stronger on the compression force side, compared to the underneath where stretch forces are a play.

Bolts and nuts was dismantled, and the brackets were pulled out from inside into the wing. This is a cumbersome job, since the front of the tail wing has access into the 6x12x12 cm boxes through the described 42 millimeter holes only. It is a bit of work, but not impossible if one is a bit creative, patient and create tools which will fit inside the rather tiny and small areas.
